POTOMAC RIVER BASIN
TOMS CREEK, ADAMS COUNTY

PENNSYLVANIA
NDS ID PA. 01135
DER ID 1-86

SECTION F DAM

PHASE I INSPECTION REPORT
NATIONAL DAM INSPECTION PROGRAM

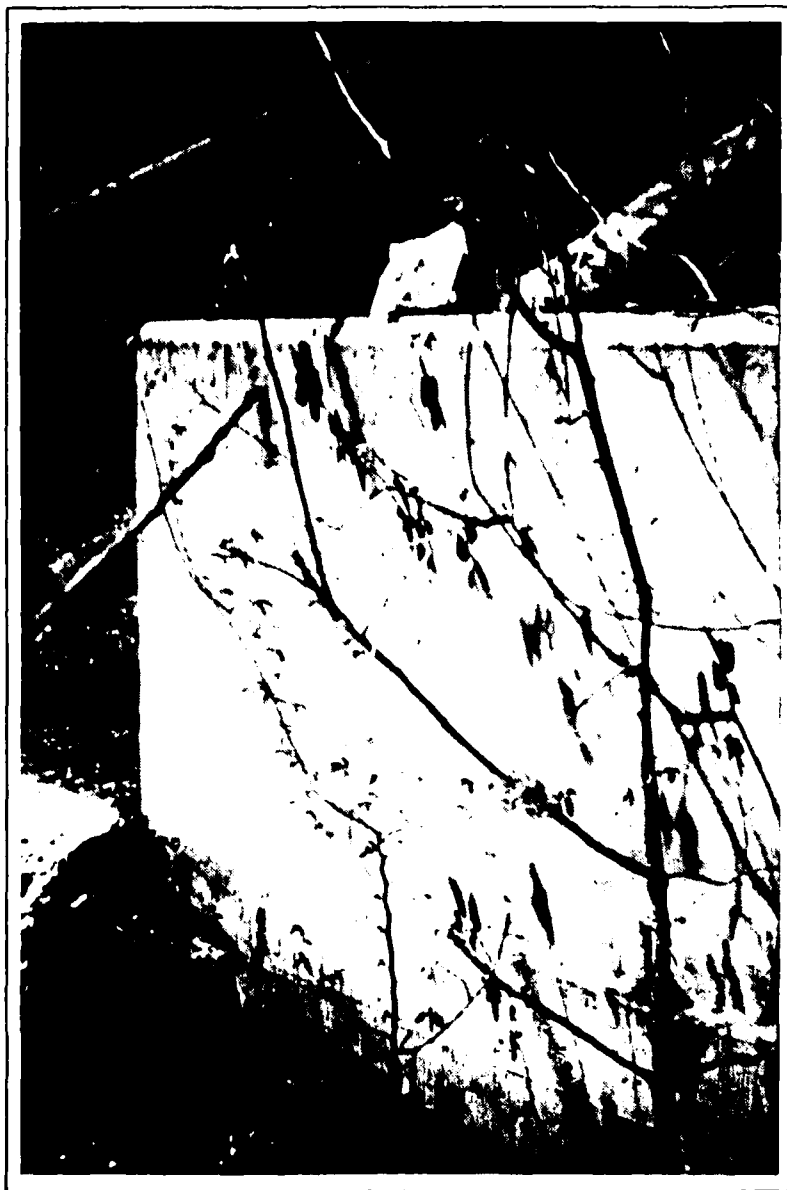
PHOTOGRAPH NO. 12

The concrete chute spillway was observed to be in good condition, with no signs of excessive scour or undermining at the outlet. A considerable amount of seepage was exiting from behind the left downstream end wall. The trees growing behind the headwall should be removed, including the root mass, and the area backfilled according to the original design drawings. The gate valve at the outlet of the pond drain should be checked and maintained to insure that it is operational.

DOWNSTREAM END OF SPILLWAY.
NOTE LARGE TREE.
